Performance Monitoring of Joint Load Transfer Restoration

KATHLEEN T. HALL, MICHAEL I. DARTER, AND JAMSHID M. ARMAGHANI

The most comprehensive load transfer restoration experiment currently in service was constructed on Interstate 10 near Tallahassee, Florida, in 1986. The performance of this experiment has been monitored continuously by the University of Illinois and the Florida Department of Transportation between 1986 and 1992. Fourteen different load transfer restoration treatments were studied. Retrofit dowel factors studied included number of dowels per wheelpath, dowel length, and dowel diameter. Double-V shear device factors studied included core wall grooving and number of devices in the outer and inner wheelpaths. The results of condition surveys, faulting surveys, and falling weight deflectometer deflection load transfer testing of the project are reported. All of the treatments were effective in limiting faulting increases to much lower levels than the faulting increases of the control sections. In addition, they all improved deflection load transfer significantly, and after 5 years in service, deflection load transfer percentages are still similar to initial postcons

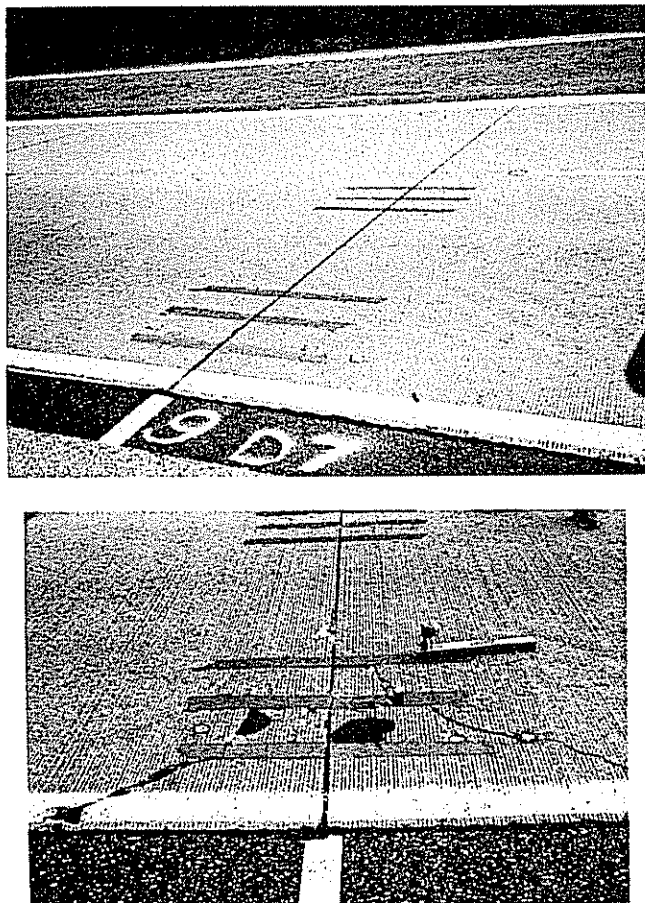
Between 1988 and 1991, however, the project developed considerable distress, particularly at the retrofit dowels. At many locations, a series of horizontal cracks was observed between the dowel slots, parallel to the joint. Often one or more cracks ran along the side of a dowel slot, and from there extended back into the slab. Some of these slab cracks extended straight from the dowel slot, parallel to the wheelpath, but most of the slab cracks that emanated from dowel slots run diagonally across the slab and intersected the lane edge a few feet from the transverse joint. This type of cracking occurred at dowel installations in both wheelpaths of the traffic lane.

Figure 5 shows Joint 9 in the eastbound D7 test section in 1988 (*top*) and in 1991 (*bottom*). The cracking, which is barely visible in 1988, reached medium severity by 1991.

FIGURE 5 Cracking at D7 dowel section, Joint 9 eastbound, 1988 (*top*) and 1991 (*bottom*) surveys.

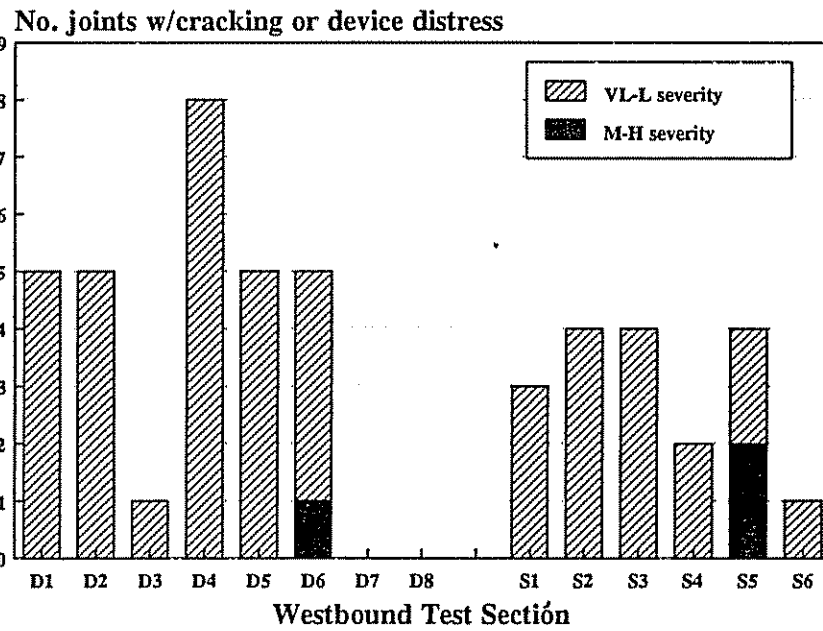
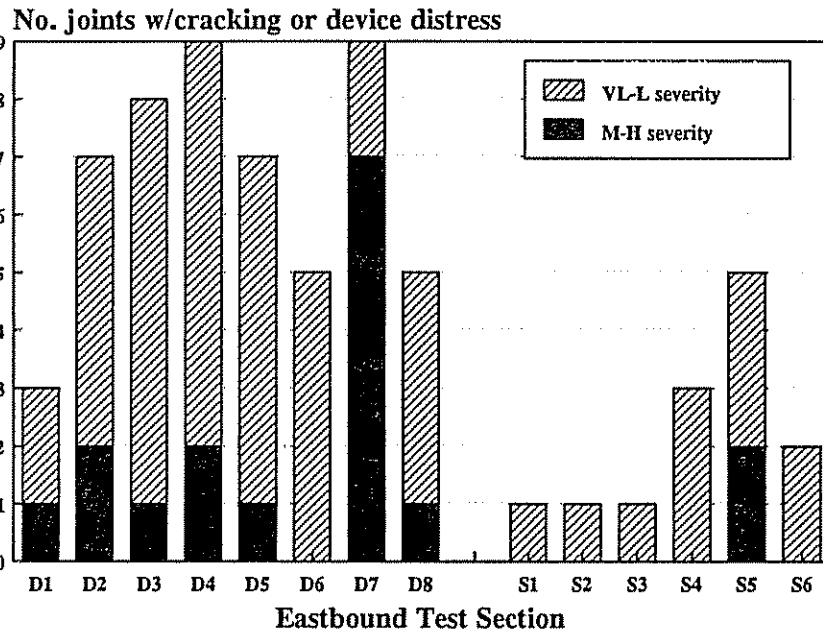
FIGURE 6 Number of joints with slab cracking or device distress.

The number of joints in each section affected by slab cracking or device distress in 1991 is illustrated in Figure 6. For most of the retrofit dowel sections, the slab cracking in the vicinity of the retrofit dowels is more prevalent and more severe in the eastbound direction than in the westbound direction. A striking contrast, for example, is seen between the eastbound and westbound D7 sections. All nine of the eastbound D7 joints have cracking, and this cracking was rated medium or high severity at seven of the nine joints. None of the westbound D7 joints have any cracking. It is worth noting that the eastbound D7 section was one of the first test sections to be constructed (see the test section layout in Figure 1).

For the three shear device treatments without core wall grooving (S1, S2, and S3), slab cracking or device distress is more prevalent in the westbound sections than in the eastbound sections. For the remaining three shear device treatments, the distress levels in the two directions were very similar.

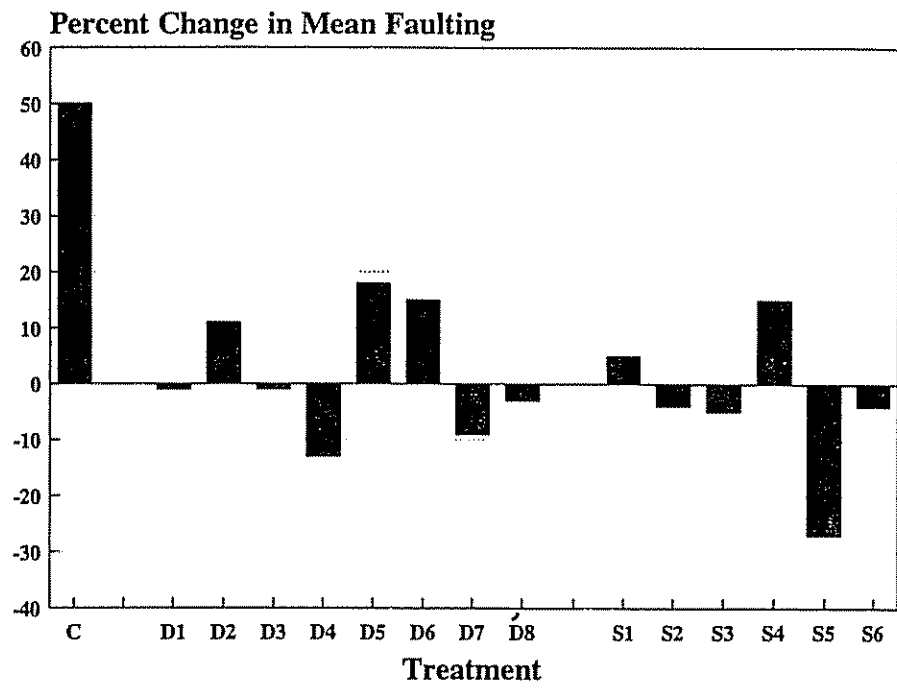
FIGURE 7 Percent change in mean faulting of control sections and load transfer and restoration treatments.

The percent change in average faulting between 1986 and 1991 is illustrated in Figure 7. The 50 percent change for control joints represents the average for all joints in the project's four control sections (36 joints total). The percent changes shown for the various load transfer treatments represent the average of the percent changes for the treatment sections in both directions (18 joints total). The percent change in control section faulting has been much greater than that in any of the load transfer treatments.

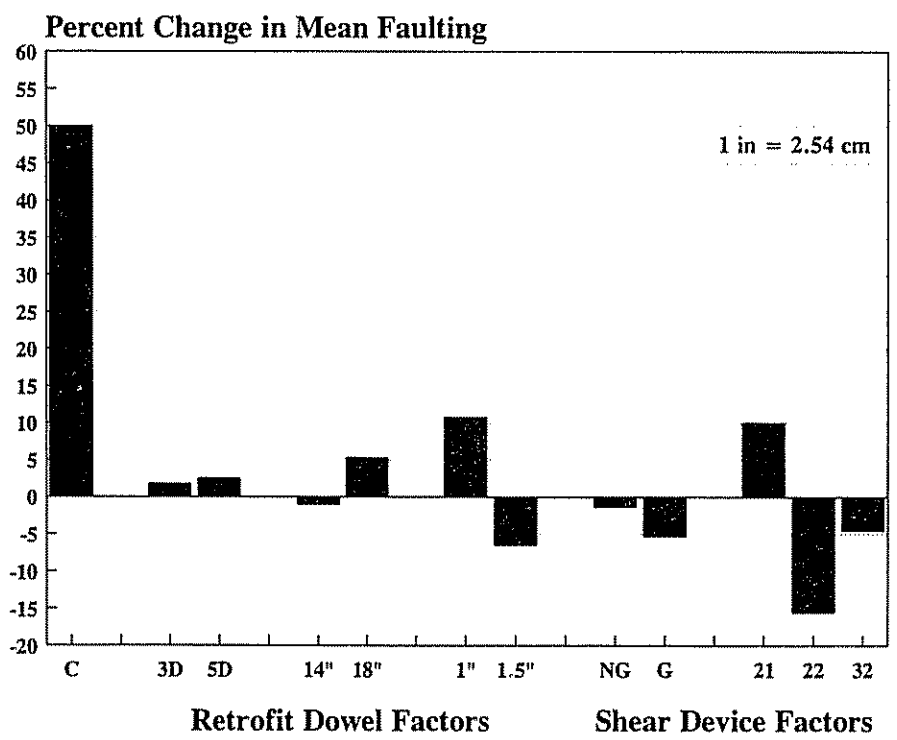
FIGURE 8 Effect of retrofit dowel and shear device factors on faulting.

Figure 8 illustrates the effects of the retrofit dowel factors and shear device factors studied on faulting performance. In each category the percent change in faulting is much less than the 50 percent change in control section faulting.

The number of dowels does not appear to have been significant: sections with three dowels per wheelpath (D1, D3, D5, and D7) and sections with five dowels per wheelpath (D2, D4, D6, and D8) both had similarly small increases in faulting.

Figure 8 suggests that dowel length may have been significant: the average faulting change of sections with 45.7-cm (18-in.) dowel bars was positive, whereas the average faulting change of sections with 35.6-cm (14-in.) dowel bars was negative. However, these results were actually mixed by section. Of the treatments with 35.6-cm (14-in.) dowels (D1, D2, D3, and D4), one of four showed a percentage increase in mean faulting, and two of four showed a positive average increase in faulting. Similarly, of the treatments with 45.7-cm (18-in.) dowels (D5, D6, D7, and D8), two of four showed a percentage increase in mean faulting and two of four showed a positive average increase in faulting.

The most significant factor in retrofit dowel faulting performance appears to have been dowel diameter. All of the sections with 2.5-cm (1-in.) dowels (D1, D2, D5, and D6) showed a percentage increase in mean faulting and a positive average increase in faulting. All of the sections with 3.8-cm (1.5-in.) dowels (D3, D4, D7, and D8) showed no positive percentage increase in mean faulting, and only D3 showed a slight positive average increase in faulting.

Grooving of the core walls does not appear to have been significant: neither the sections without grooved core walls (S1, S2, and S3) nor the sections with grooved core walls (S4, S5, and S6) showed an overall average percentage increase in faulting. In each group, one treatment (S1 and S4, respectively) showed slight faulting increases, and the other two treatments (S2 and S3 and S5 and S6) did not show positive changes.

Of the three shear device patterns used, the only one to show an increase in faulting was the weakest pattern (two devices in the outer wheelpath and one in the inner wheelpath for S1 and S4). Both of the other patterns (two devices in each wheelpath for S2 and S5 and three devices in the outer wheelpath and two in the inner wheelpath for S3 and S6) showed no positive increases in mean faulting.

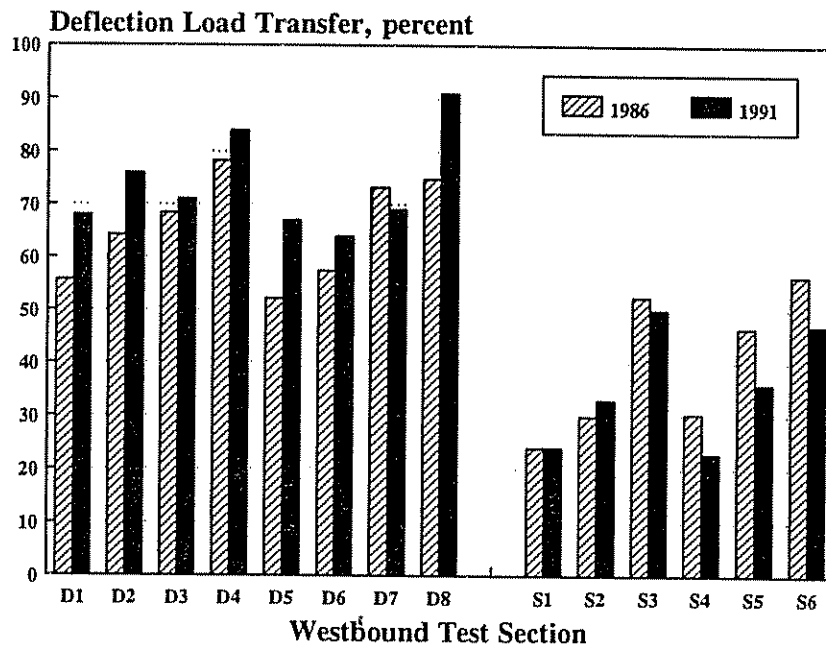
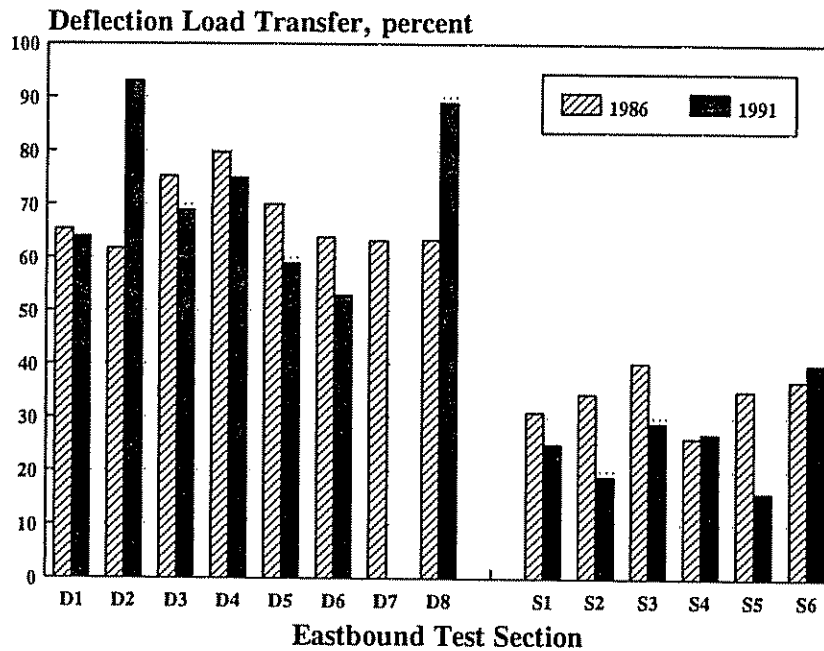
FIGURE 9 Comparison of 1986 and 1991 deflection load transfer efficiencies in test sections.

Deflection testing was conducted again by the Florida DOT in early 1992. The load transfer efficiencies of the various test sections are compared with the load transfer efficiencies in 1986 in Figure 9. In general, the results are similar.

The load transfer efficiencies of most of the retrofit dowel sections in 1992 are within 15 percent of their 1986 values. Most of the westbound dowel sections actually have higher mean load transfer efficiencies now, whereas most of the eastbound dowel sections have lower load transfer efficiencies now. In one eastbound dowel section (D7), joint load transfer measurements were not taken, presumably because of excessive joint deterioration.

The load transfer efficiencies of most of the shear device sections in 1992 are within about 10 percent of their 1986 values. Two eastbound sections (S2 and S5) appear to have dropped to fairly low load transfer levels (less than 20 percent). Sections without grooved core walls do not have significantly different load transfer efficiencies than corresponding sections with grooved core walls. In the westbound direction, the load transfer efficiency improves with increasing number

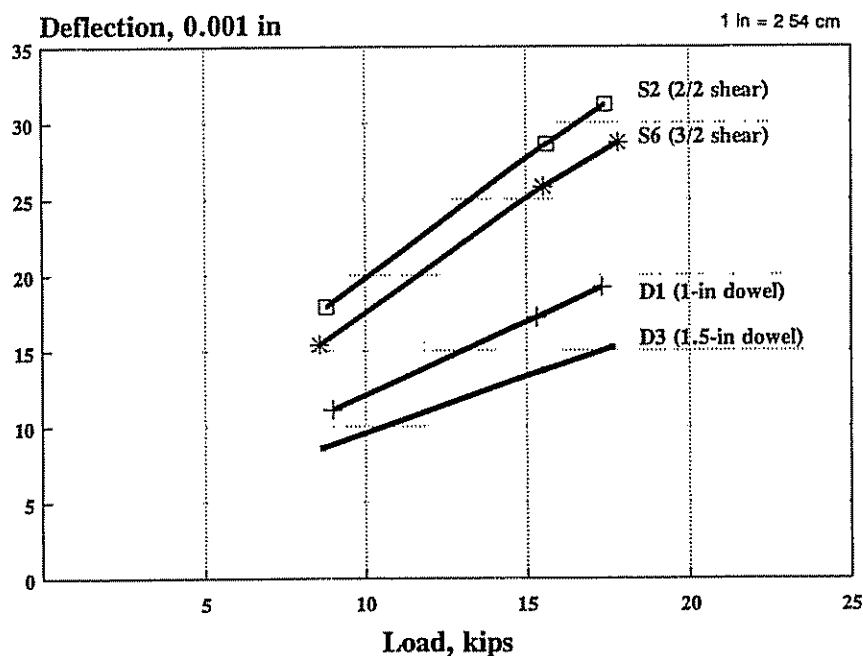
FIGURE 10 Example of load-versus-deflection results at slab corners for dowels and shear devices.

Figure 10 illustrates sample load versus deflection plots for representative joints in two dowel sections and two shear sections. The dowelled joints show lower deflections at each load level than the shear joints. Between the two dowelled joints shown, the joint with 3.8-cm (1.5-in.) dowels shows lower deflections than the joint with 2.5-cm (1-in.) dowels. Between the two shear device joints shown, the one with three devices in the outer wheelpath shows lower deflections than the one with two devices in the outer wheelpath.

The trends illustrated in Figure 10 are typical of the load-versus-deflection behavior of joints throughout the project, although there is significant variation from joint to joint within each test section. In general, joints with 3.8-cm (1.5-in.) dowels had about 30 percent lower corner deflections than joints with 2.5-cm (1-in.) dowels. Other retrofit dowel factors did not have any significant effect on corner deflections. Overall, dowelled joints had about 30 percent lower corner deflections than joints with shear devices. Joints with 3.8-cm (1.5-in.) dowels had about 38 percent lower corner deflections than joints with shear devices.
