Slab Stabilization

TECH BRIEF

*This document is a brief technical summary of the MoDOT case study **Slab Stabilization Case Study for Missouri** which is included in a larger report, **Concrete Repair Best Practices: A Series of Case Studies**, Publication no. cmr 17-013, November 2017.*

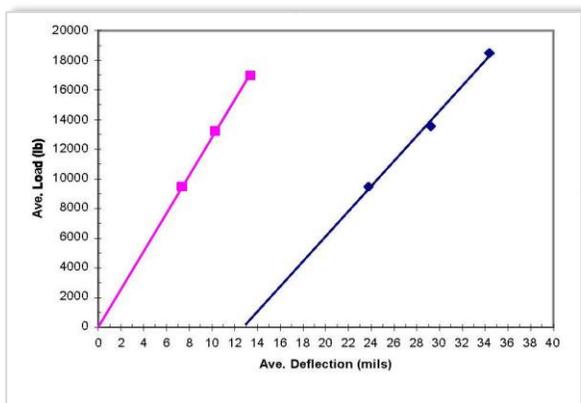
Figure 1. FWD load versus corner deflection before and after undersealing. Note that “after” undersealing the deflection vs. load line goes through the origin indicating restored support).

The “Before Undersealing” plot does not extend through the origin but along the “Deflection” axis, indicating a loss of support beneath the slab/stabilized base (e.g., high deflection for a given load). Once the joint has been injected with material (polyurethane, in this project), the post-stabilization (or undersealing) FWD load-deflection plot extends directly through the origin, indicating that the loss of support has been filled and full support has been restored with a much lower deflections. Missouri DOT concluded that, “The FWD is an efficient tool to use for void
