# CPR – REBUILT TO LAST

## Interstate 10, San Bernardino, CA

### >>> PARTIAL-DEPTH REPAIR

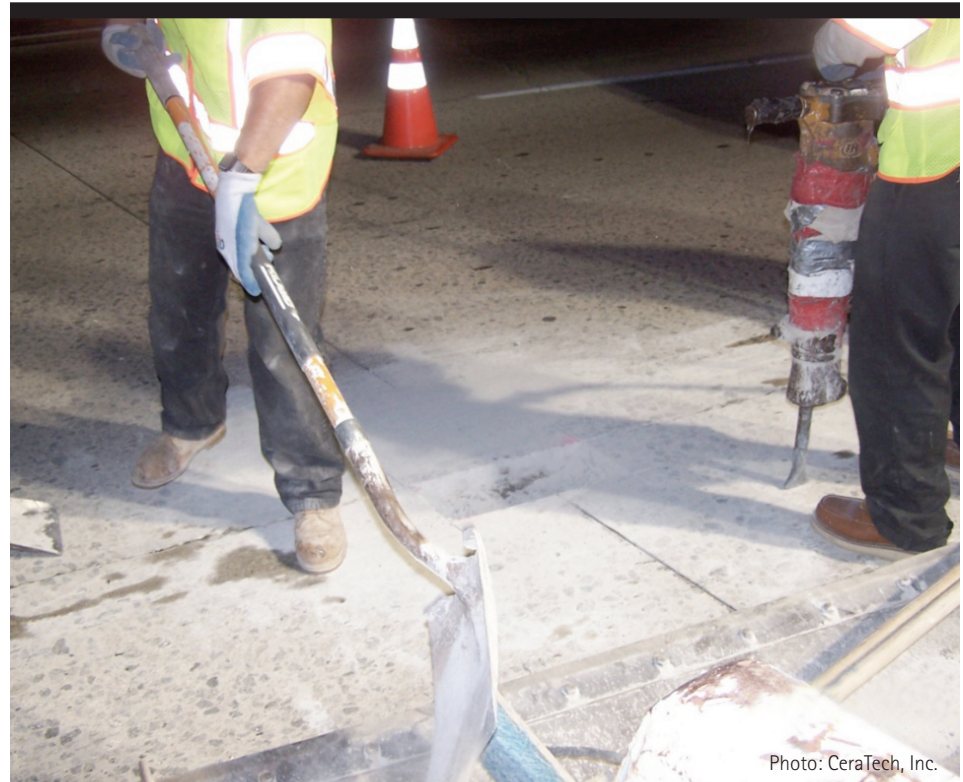
This project was repaired using a new product, *CeraTech D.O.T. Line rapid repair concrete*, which is an environmentally-friendly fly-ash based cementitious material made from waste by-products. Creating a finish similar to Portland cement based concrete, this material cleans up easily with water and is packaged pre-blended with aggregate. During the beginning stages of construction, diamond sawing of the perimeter followed by chipping was used to remove the deteriorated concrete. With a shallow vertical saw-cut approximately two to four inches deep performed around the perimeter of the spalled area, a 15 to 30 pound jackhammer was then used to remove the deteriorated concrete until sound concrete was exposed. The perimeter of the repair area

needed to extend six inches into sound concrete, per Caltrans requirements, which resulted in an area rectangular in shape, deep enough to expose sound concrete, free of loose material and clean. With the majority of spalls next to a transverse or longitudinal joint, a foam board insert was placed in the existing joint, preventing the patch material from filling the joint and creating an incompressible condition. The foam board extended four inches beyond the patched area. The *CeraTech D.O.T. Line* product was mixed onsite, resulting in a concrete product with a four-inch slump and a 25-minute working time. After dampening the clean, chipped out spall area, the material was placed, screened off and finished with a trowel. The final surface texture applied to the patches was a broom texture.

Each 54-pound bag of patch material was mixed with two quarts of water for seven minutes, which the manufacturer says will result in a compressive strength of 2,500 psi in a maximum of two hours. This is considered the minimum strength to open to traffic. Workers operated at night by way of a lane closure.
