# **AN EVALUATION OF RETROFIT LOAD TRANSFER MATERIALS AND DOWEL BAR CONFIGURATIONS**

David L. Rettner, P. E.  
Chief Geotechnical Engineer, Minnesota Department of Transportation,  
1400 Gervais Avenue, Maplewood, MN 55109  
e-mail: dave.rettner@dot.state.mn.us

Mark B. Snyder, Ph.D., P. E.  
Executive Director, Concrete Paving Association of Minnesota  
6300 Shingle Creek Parkway, Suite 325  
Brooklyn Center, MN 55430  
e-mail: mbsnyder@cpamn.com

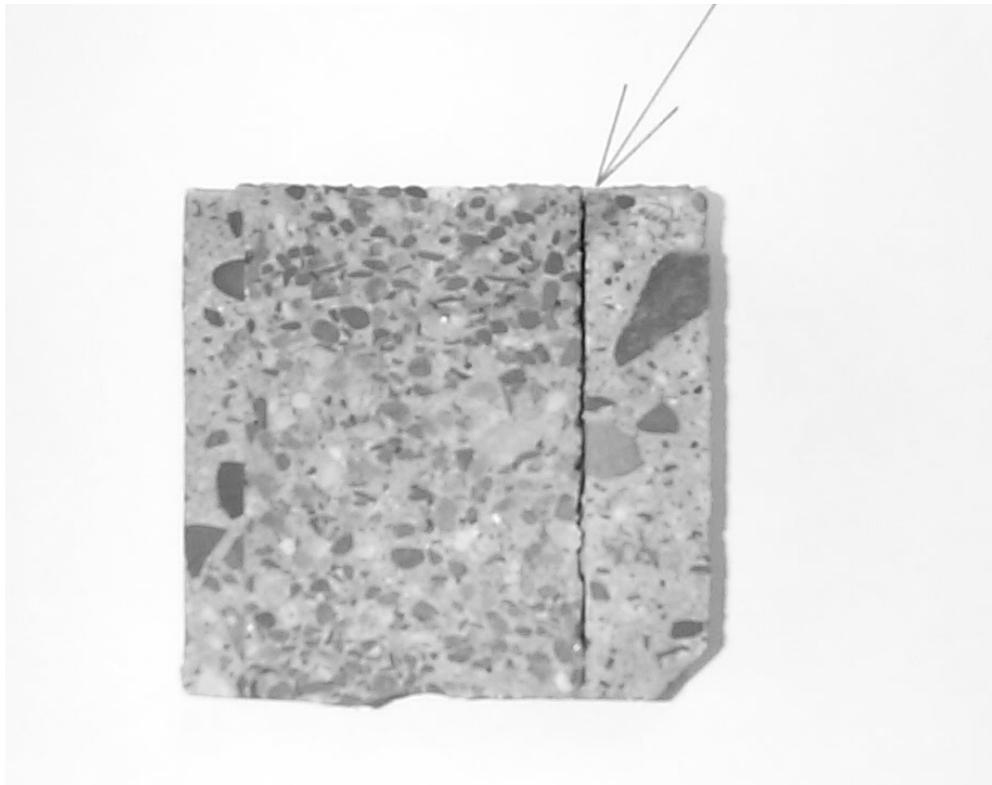
Subsequent coring of several of the slots and analysis of the cores showed that many of the slots that had been filled with either patching material suffered from a lack of bond between the patching material and either one or both vertical faces of the slots (Figure 5). The cores also showed that the patching materials were mainly bonding to the rough surface at the bottom of the slot that had been fractured off by a jackhammer. Both patching materials also exhibited a substantial amount of plastic shrinkage cracking, although it was more pronounced in the 3U18. They both also had significant voids on the underside of the dowel bars. Several of the patches also exhibited hairline cracks radiating from the caps on the ends of the dowel bars that appeared to be caused by shear forces.<sup>2</sup>

It was hypothesized that the lack of bond between the patching material and the slots was caused by excess water in the patching material causing excessive shrinkage of the patches. The voids on the underside of the dowel bars and chairs also appeared to be caused by the presence of excess water that coalesced under the bars instead of bleeding to the surface of the patch. This theory is supported by a lack of aggregate in the patching material adjacent to these voids, indicating a high water content (Figure 6).

It was also thought there might have been insufficient sand blasting of the slots to completely remove the slurry left behind by the wet saws during the removal process. It was also possible that the smooth vertical face that results from using saws didn't provide an adequate surface for the patching material to bond to, suggesting that much more aggressive sandblasting would be useful in any future work of this type.

Typical Debonded Vertical Face  
Figure 5

- 1) The water content of any patching material used to backfill retrofit dowel bars should be carefully controlled and the minimum necessary to allow for the proper placement of the material should be used to reduce the probability of shrinkage cracks and debonding.

- 2) Extraordinary effort should be made in to insure that all faces of the removal area are thoroughly cleaned and abraded by sand-blasting to assure the best possible bond between the patching material and the pavement.

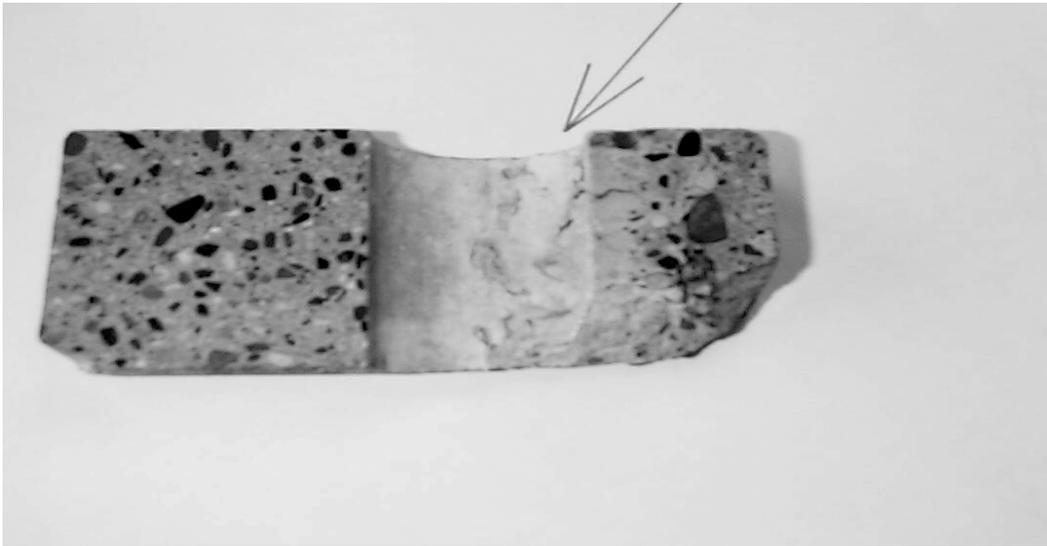
Example of Voids in Mortar Around Dowel Bar  
Figure 6

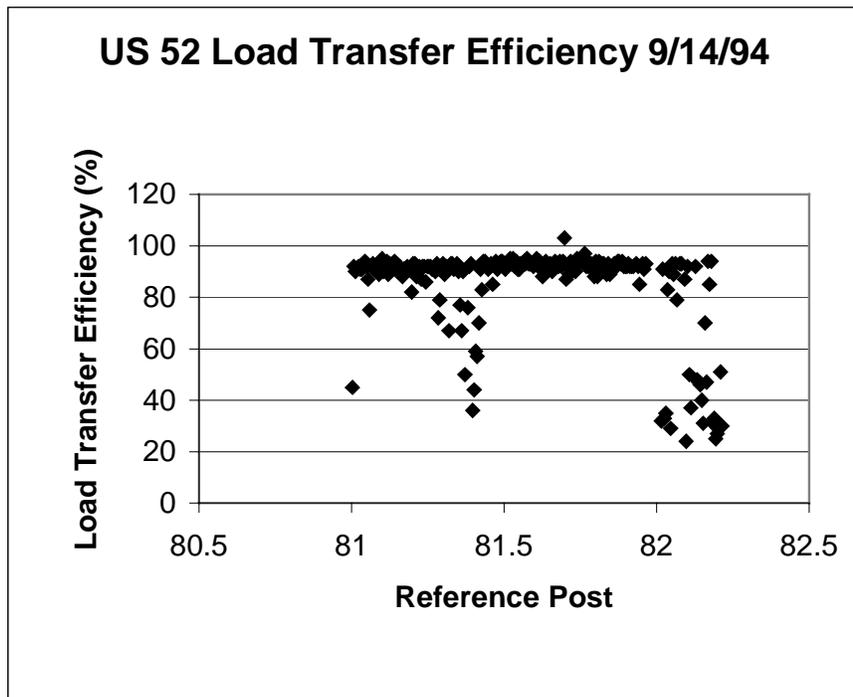
Figure 7

Prior to the start of the project a falling weight deflectometer (FWD) was used to measure the load transfer efficiency (LTE) of each of the cracks in the right wheel-path of the right lane for both the control section and the test sections (Figure 7). The majority of the cracks still had LTE's above 90% (calculated by the equation  $(D_l/D_{ul}) \times 100\%$ ) but there were several cracks where the LTE had dropped below 50%, between RP 81.3 and 81.5 and between RP 82.0 and 82.2. The LTE of the test sections was measured again in November of 1995, one year after the retrofit dowels had been placed, and a substantial improvement was seen (Figure 8) in these areas. The LTE of the entire section appears to be lower than in 1994, with an overall average of 85% and several cracks below 80%. This is most likely due to the relatively high pavement surface temperature during the testing in 1994 that may have contributed to the load transfer between slabs due to expansion of the pavement. The pavement temperatures at the time of the FWD testing were between 22°C and 41°C in 1994 and between 5°C and 8°C in 1995.

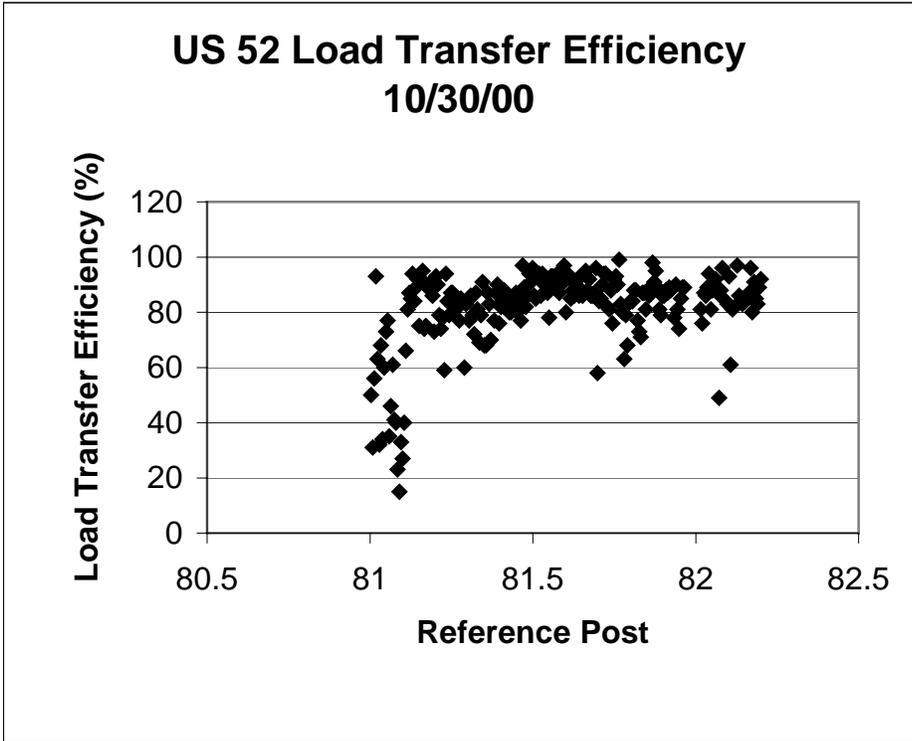
Figure 9

The LTE of the test sections was measured again in October of 2000 (Figure 9) with a FWD and it had remained 85% on average with few cracks measured below 80%. The majority of the

cracks shown below 80% were formed after the time the retrofit installation was performed. The pavement surface temperature at the time of testing was between 3°C and 16°C.

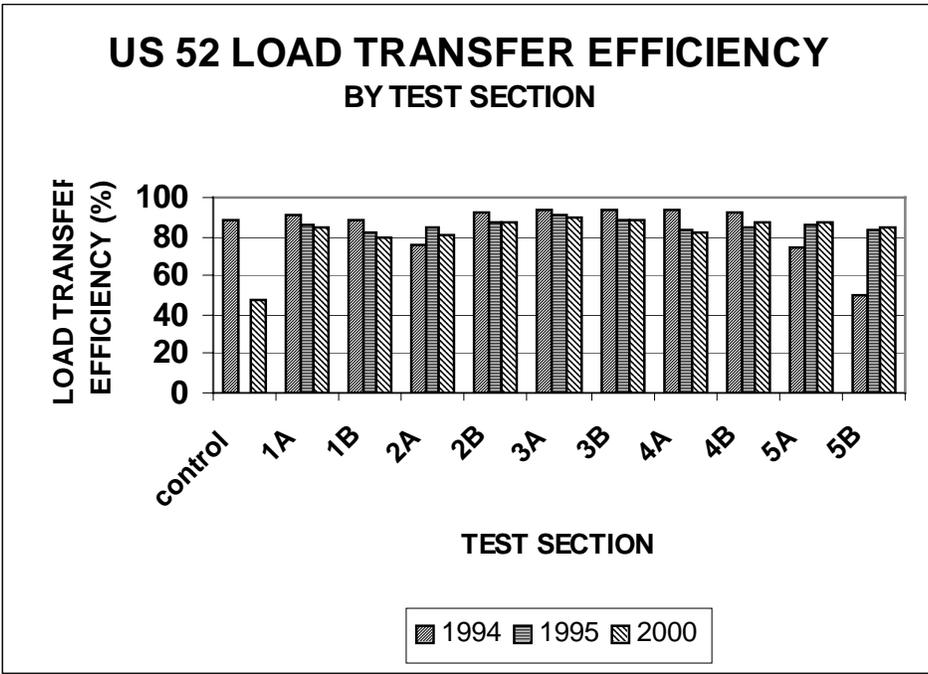
Figure 10

A comparison of the different dowel bar configurations shows no significant difference exists in the LTE of any of the test sections after 6 years of traffic (Figure 10). All of the test sections had average LTE's above 80% and 6 of the 10 were at 85% or above and are summarized in Table 2. The average LTE of the right lane, right wheel path dropped from 85.6% to 85.1% during this time period. All of the test sections had approximately the same loss in LTE with time, losing only an average of 0.5% in 5 years. Test section 2A had the greatest loss of 4%. This test section also had one of poorest LTE's prior to the dowel bar retrofits were installed. Test section 4B showed a gain of LTE of 3% between 1995 and 2000. This increase may be due to the higher pavement temperature during testing in 2000 relative to 1995.

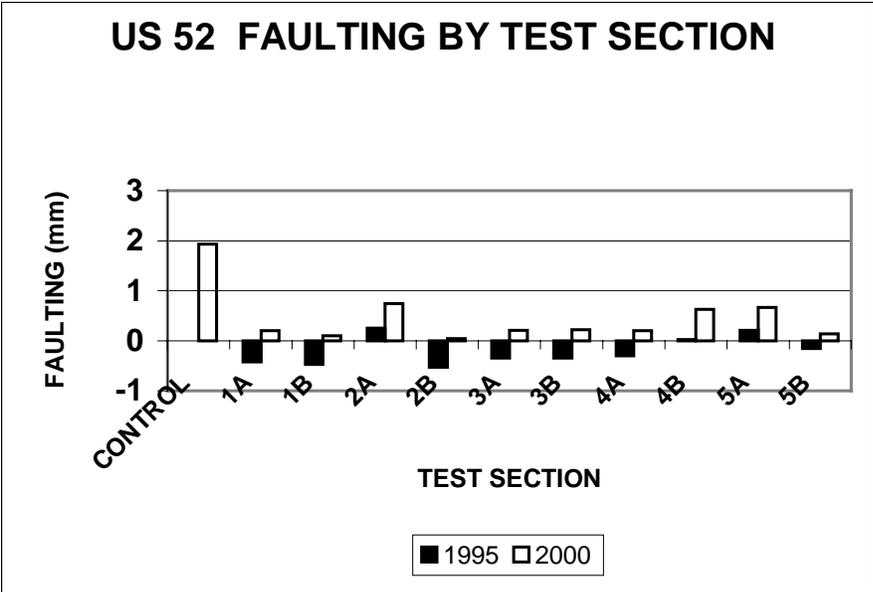
Figure 12 shows a summary of the average faulting measurements for each test sections and the difference between the average measured in 1995 and 2000. It can be seen that several of the test sections had negative faulting in 1995 and that none of the sections had an absolute average fault measurement greater than 0.53mm (test section 2B, -0.53mm). By October 2000 all of the test sections had seen an increase in faulting. The average increase for each test section was 0.52mm. Test section 2A showing the greatest average faulting measurement of 0.75mm, and test section 5B had the lowest with 0.30mm. The control section had an average faulting measurement of 1.92 mm in 2000. The control section faulting was not measured in 1995 so a

comparison cannot be made. However, the faulting in the control section is significantly greater than that of all of the test sections, which indicates that the retrofit dowels do reduce faulting.

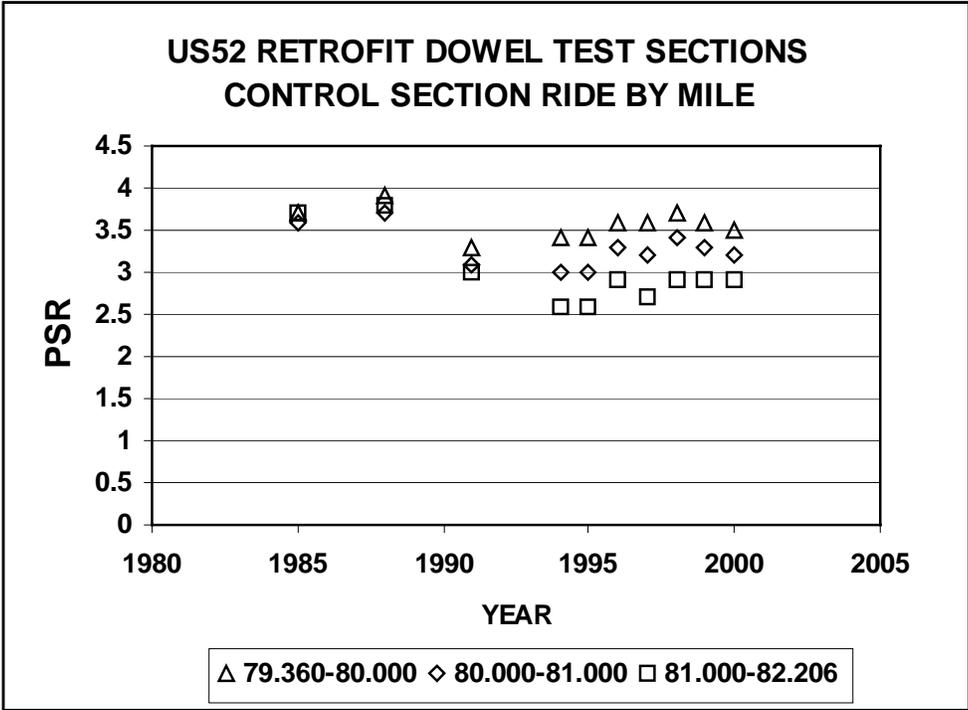
When this section of US 52 was originally constructed in 1994 it had a PSR of 3.7 which was typical for a new concrete pavement at that time. Figure 13 shows the PSR for the pavement from 1985 through 2000 broken down into three segments. By 1994 the ride for the first two segments, RP 79.360 and 80.000 and RP 80.000 and 81.000, was substantially better than that of the segment between RP 81.000 and 82.206. This was due in large part to the relatively low number of uncracked panels in the first two segments, less than 10%, compared to the third segment which had over 95% cracked panels. The ride was again measured in 1995, after the retrofit load transfer was installed, and every year thereafter. The figure shows that the ride for all sections increased in 1996, most likely due to changes in the measuring equipment, and has remained relatively constant in each segment since then. It is unlikely that the 0.2km between RP 81.030 and 81.110 that was undoweled and had a larger amount of faulting contributed negatively to the overall ride measurement of the third segment because of its short length relative to the entire segment.

- 6) Retrofit load transfer reduced the increase in faulting in the roadway by a substantial amount over doing nothing. However, the poor ride that existed prior to the retrofit was maintained afterwards, which strongly suggests that poor riding pavements should be diamond ground after the load transfer is established.
