# CPR: BUILT TO LAST

## Eielson Air Force Base, Fairbanks, AK

### >>> DIAMOND GRINDING AND GROOVING

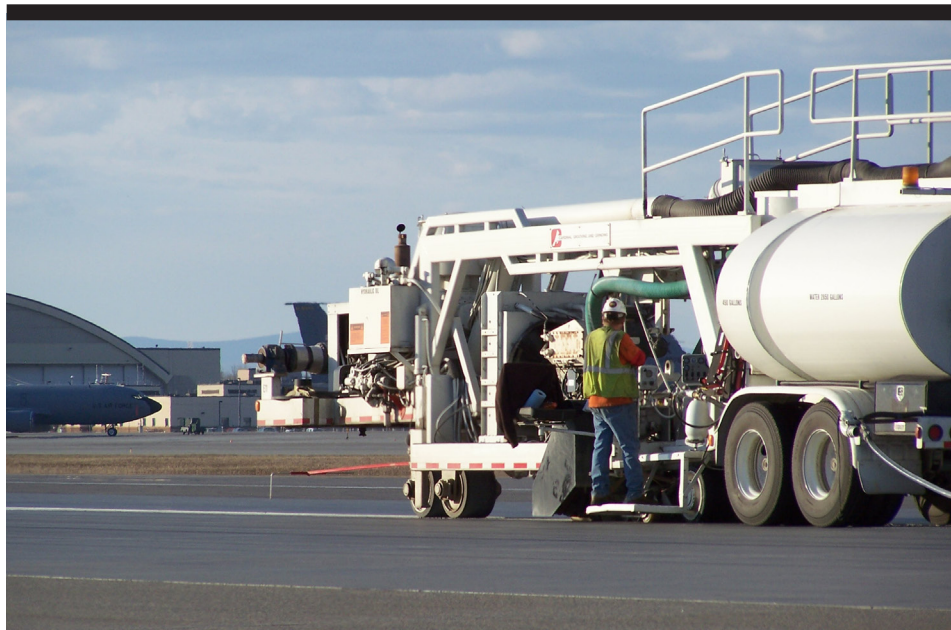
**IT IS NO SECRET** that winters in Alaska can be harsh—not just for its residents, but also for the state’s infrastructure. At Eielson Air Force base (AFB) in Fairbanks, drastic variations in seasonal temperatures of around 100 degrees and extreme winter weather conditions accentuated by the wear caused by constant snow and ice removal had damaged and deteriorated the 14,530-foot concrete keel section of runway 14-32, which is used by fighter aircraft from the 354th Fighter Wing and by large refueling tankers. Repairs and retexturing were required to avoid potentially serious and expensive accidents that could be caused by aircraft losing control on the worn surface.

Approximately 200 locations were repaired on the runway where spalling of the concrete had occurred. Sizes and depths of spalled areas ranged from 5 to 12 inches in width and length and 4 to 14 inches in depth.

Concrete was originally chosen for the runway’s 75-foot-wide keel section since it is a material that can withstand the major temperature variations, harsh winter conditions and the process of repeated snow removal by plows. Diamond grinding was used to remove the existing grooved surface before a new grooved surface could be created. In addition, there was a requirement to remove old sealant from the joints of the runway and replace it with new sealant material, followed by striping and marking.

The project was to be completed in four phases. Each phase was to be completed with only a seven-day buffer between the end of one phase and the commencement of the next. In each phase, the old grooves had to be ground out to the satisfaction of the engineer before new grooves could be cut into the runway. Then the old sealant was removed and the joints cleaned, so that new sealant could be installed.
