# Diamond Grinding for Roadway Noise Control

Areg Gharabegian and Emery Tuttle, Parsons Corporation, Pasadena, California

**The results of resurfacing a roadway to reduce the noise from tire/pavement interaction are presented. Effects of truck traffic and the use of soundwalls for environmental noise control are considered as well.**

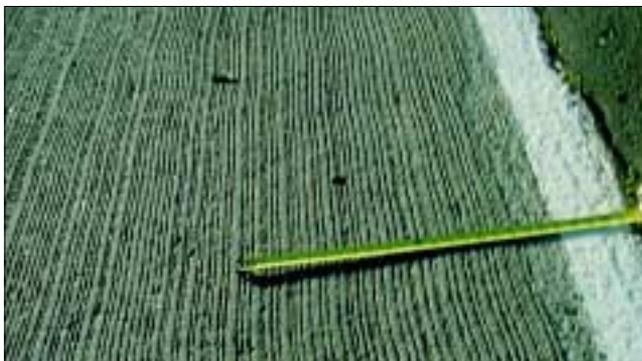
Figure 1. Longitudinal grooves of Route 101 at the test segment.

These considerations led to the selection of a measurement location along northbound U.S. Highway 101 near the City of Geyserville. In this area there is an adequately long section of longitudinally grooved pavement with a nearby section of smooth, diamond ground pavement. The measurement site for the grooved pavement surface ('before') was selected based on its similarity to the highway areas where the road surface was diamond ground ('after'). The two sites were within several miles of each other. Figures 1 and 2 show the surface of Route 101 in the area with longitudinal grooves and areas with diamond grind, respectively.

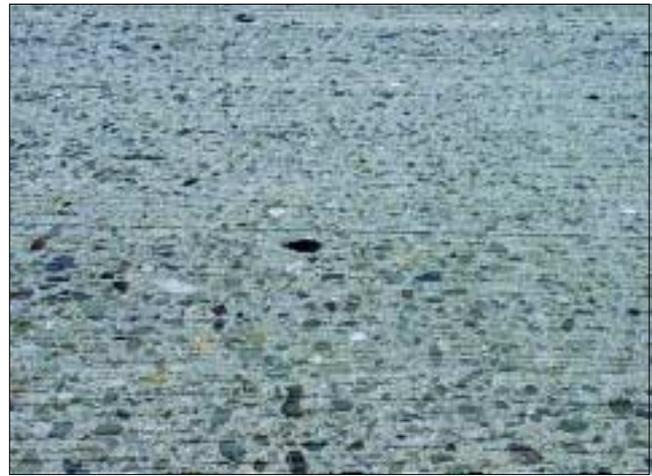
Figure 2. Route 101 surface after diamond grinding.

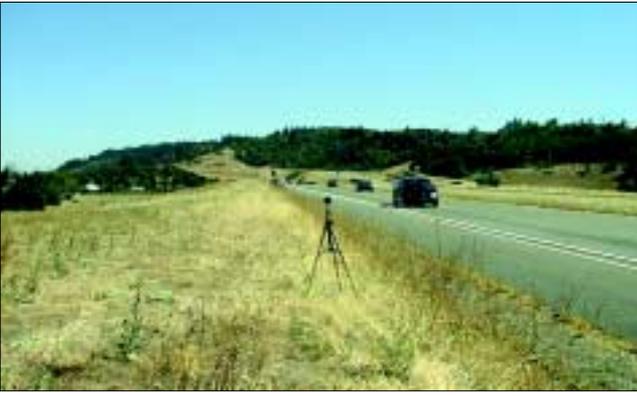
Figure 5. Microphone at 7 m (grooved Site 1).

**Pass-by Spectrum Noise Measurements.** The objective of the measurements was to collect data for individual vehicle passbys. Light traffic conditions at this location of U.S. 101 made this possible. A Larson Davis model 2900 2-channel real-time spectrum analyzer (RTA) was set up to measure and store 1/2-sec intervals of the sound level time history for both the overall broadband and 1/3-octave frequency bands. Channel 1 recorded the noise level at a distance of 7.5 m (25 ft) from the centerline of the outside lane of travel of northbound U.S. 101. Channel 2 recorded noise levels at 15 m (50 ft). Figure 3 shows a schematic diagram of the arrangement of the noise measurement instrumentation. Figures 4 and 5 show the measurement site for the longitudinally grooved (Site 1) and Figures 6 and 7 show the measurement site for the diamond grind (Site 2).

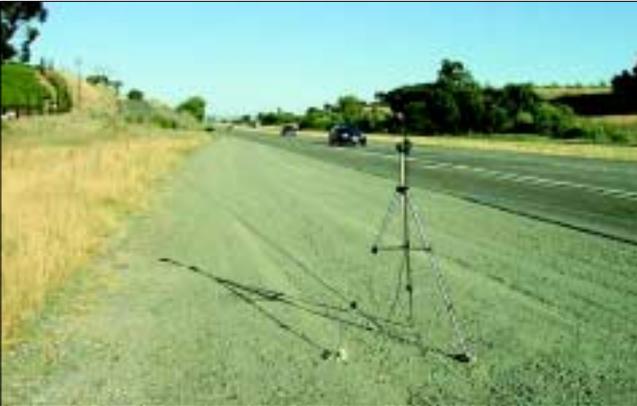
Figure 6. Microphone at 7 m, looking south (diamond grind Site 2).

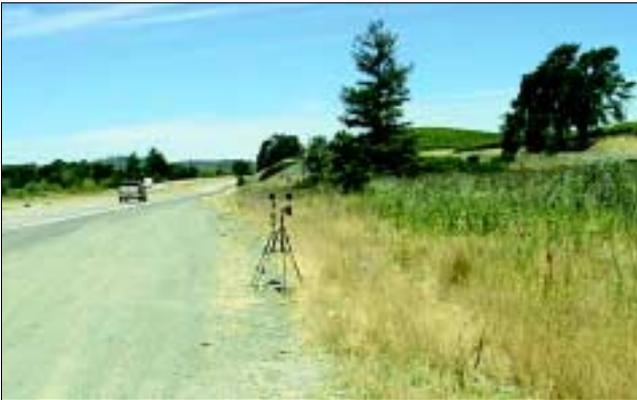
Figure 7. Microphone at 7 m, looking north (diamond grind Site 2).
