# **AN EVALUATION OF RETROFIT LOAD TRANSFER MATERIALS AND DOWEL BAR CONFIGURATIONS**

David L. Rettner, P. E.  
Chief Geotechnical Engineer, Minnesota Department of Transportation,  
1400 Gervais Avenue, Maplewood, MN 55109  
e-mail: dave.rettner@dot.state.mn.us

Mark B. Snyder, Ph.D., P. E.  
Executive Director, Concrete Paving Association of Minnesota  
6300 Shingle Creek Parkway, Suite 325  
Brooklyn Center, MN 55430  
e-mail: mbsnyder@cpamn.com

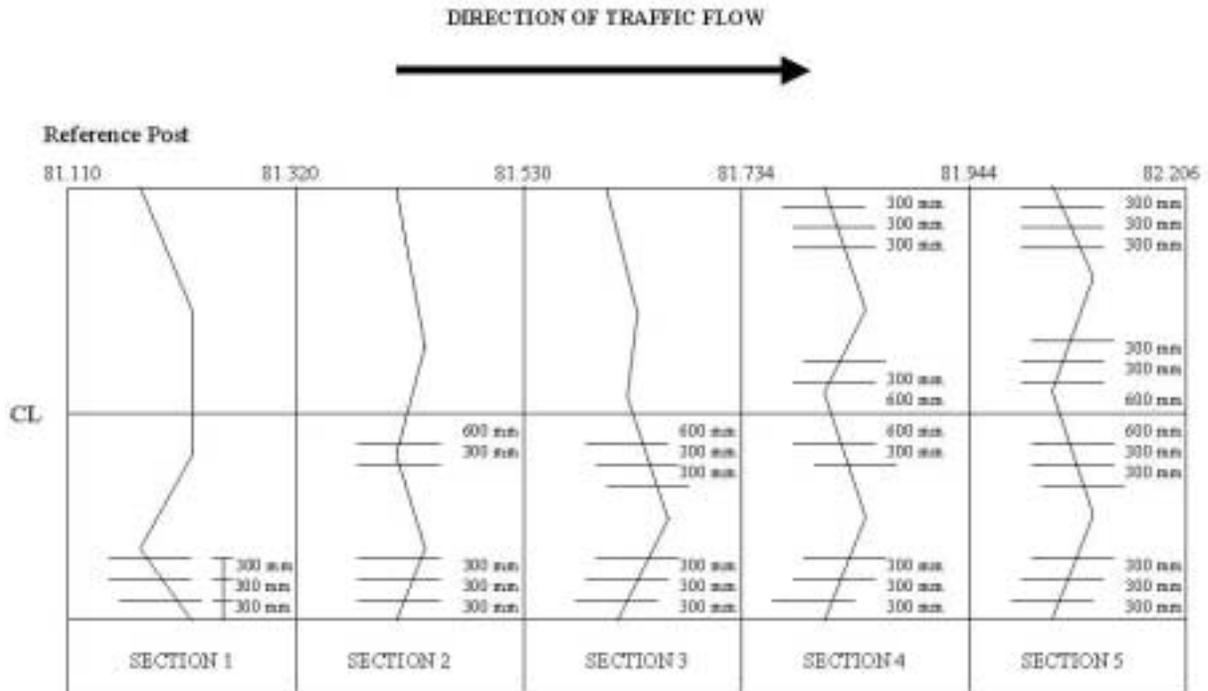
Figure 1

The project was divided into 5 test sections (Figure 1) where different load transfer configurations were installed. There was an additional control section between RP 81.0 and 81.2 where no dowels were installed. Each test section was divided in half with the first 20 slots using 380mm x 37.5mm dowel bars (subsection A) and the second 20 slots using 457mm x 37.5mm dowel bars (subsection B). The slots cut at the first four cracks in each section were filled with the proprietary patching material and the next 16 were filled with the standard 3U18 patching mix. Table 1 shows the mix design of the 3U18 material. The proprietary mortar material was mixed per the manufacturer’s instructions. It was extended with aggregate passing the 9.5mm sieve at the rate 1.4kg aggregate per 1kg of mortar. Table 2 shows the typical strength gain characteristics of both materials.

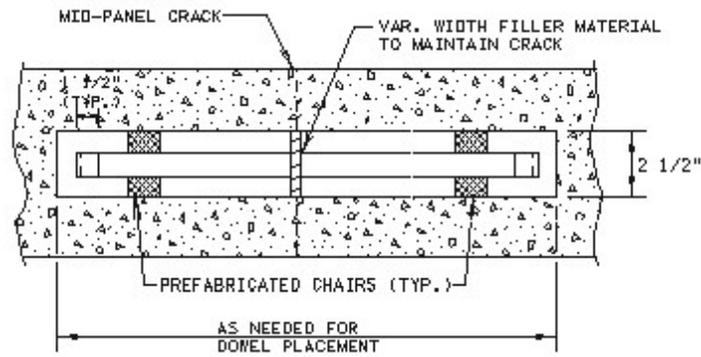
Figure 2<sup>3</sup>

The typical dimensions of the slot and retrofit dowel installation are shown in Figures 2, 3, and 4. The slots were made by parallel cuts of a pavement saw approximately 65mm apart, approximately 150mm in depth and 900mm in length. The Contractor used a piece of equipment that could cut three slots simultaneously. This system allowed for much faster removal of the concrete and better alignment of the slots with the centerline of the pavement. The concrete was then removed by placing a light jackhammer on one end of the sawed slot and applying a small amount of force that caused the concrete in the slot to “pop” out of the pavement. A minor amount of additional jackhammer work was necessary to clean the bottom of the slot to the

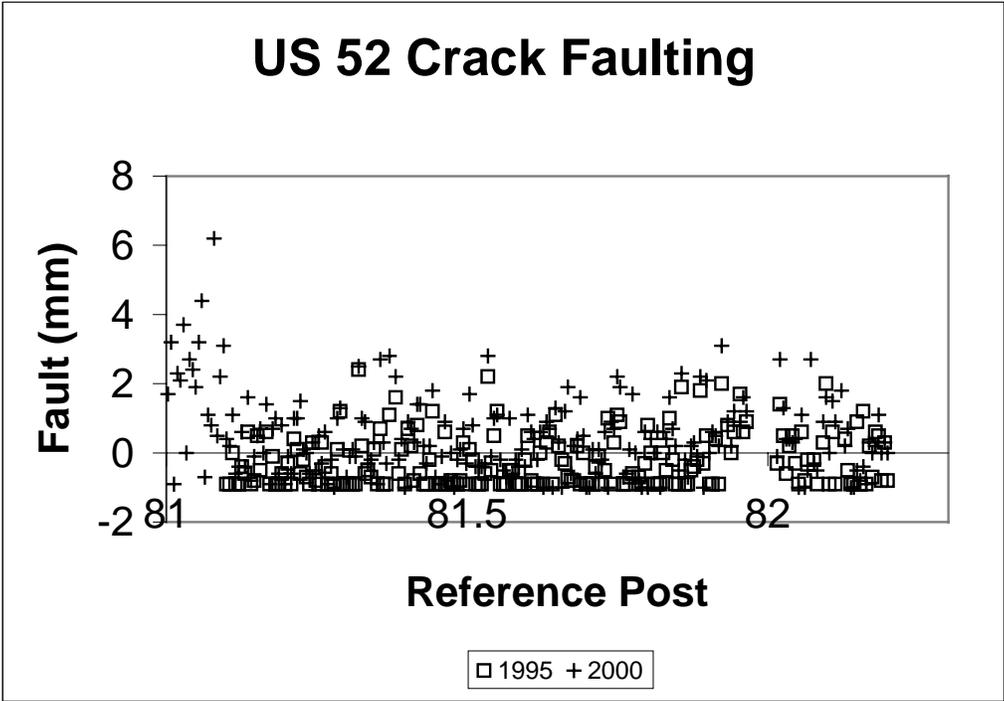
Figure 11

Faulting measurements were taken during September 1994, November 1995, and October 2000 using the Georgia Faultmeter (Figure 11). The faulting was measured in the outer wheel path of the right lane. Unfortunately, it was not possible to accurately determine which measurement went with which crack for the 1994 data so it was not used for this analysis.

- 6) Retrofit load transfer reduced the increase in faulting in the roadway by a substantial amount over doing nothing. However, the poor ride that existed prior to the retrofit was maintained afterwards, which strongly suggests that poor riding pavements should be diamond ground after the load transfer is established.
