# Improving Rideability at a Newly Constructed Pavement-Bridge Interface A Case Study

**ABSTRACT:** Ride quality is a key factor in the long term performance of our highways and bridges. Improved smoothness results in increased longevity and lower annual maintenance costs in addition to greater comfort and safety for the traveling public. This paper examines the rideability of a newly resurfaced bridge deck and the associated tie-in with the existing pavement on a construction project in Ohio which was subjectively deemed “too rough” to remain as is. It discusses the selection of diamond grinding as the chosen corrective action, the use of the diamond grinding simulation found within the FHWA’s ProVAL software to develop a grinding strategy, and an objective assessment of ride quality based on the International Roughness Index (IRI) before and after grinding.

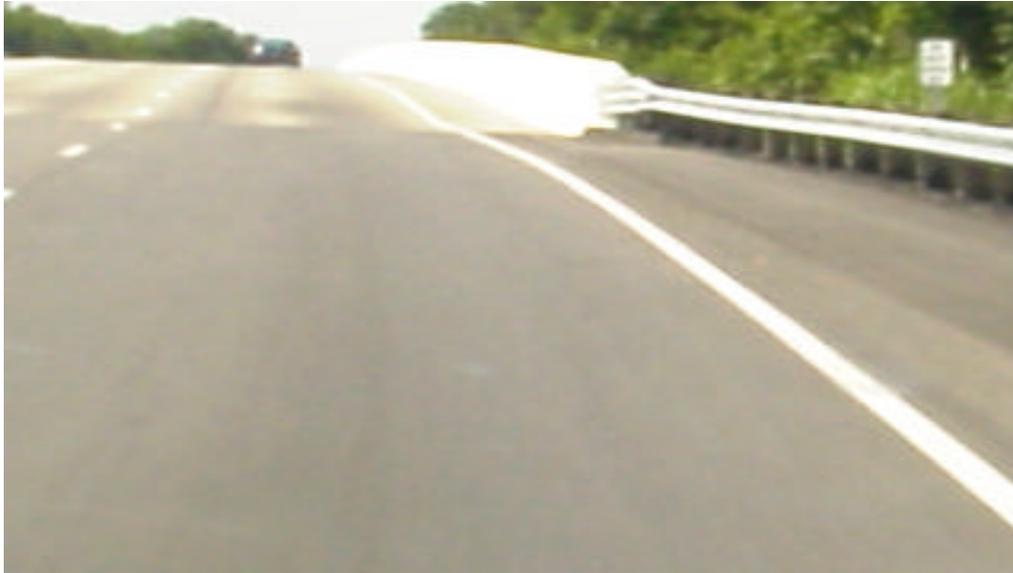
Personnel from ODOT’s Office of Pavement Engineering collected road profiles on the project with one of ODOT’s high speed non-contact inertial profilers in order to perform a quality assurance review of the contractor’s supplied smoothness data on the pavement. Road profiles are different from the general profile found in construction plans in that they are a series of discrete relative elevations along each wheel path of the roadway (Sayers & Karamihas, September 1998). In this case, the relative elevations were collected at 25 mm (1 inch) intervals longitudinally. Road profiles were collected on the entire length of the project including the bridge. Although the Prime earned a bonus for pavement smoothness on the project, there were ride issues with the pavement coming into the bridge. The rideability at the pavement-bridge interface, particularly the northbound lanes at the south end of the structure, indicated a need for improvement. Digital forward looking images were taken while road profiles were collected. Figure 1 shows the asphalt

surface is high coming into the bridge. Also noticeable in the photo is an oil spot on the deck in the center of the outside lane. This is indicative of a roughness event upstream which causes vehicles to lose oil from their engines/undercarriage due to the induced vibration, dropping it on the highway surface.

Figure 1. Approaching bridge northbound right lane.

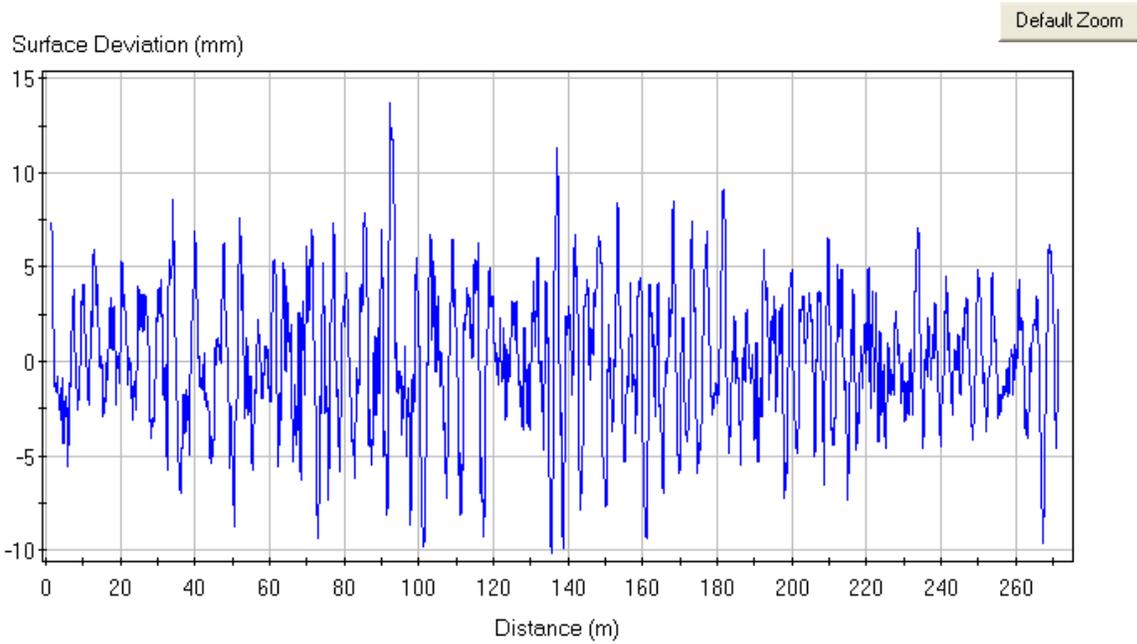
ODOT has been using ProVAL software since it was first released in 2001. ProVAL (Profile Viewing and AnaLysis) is an engineering software application that allows users to view and analyze pavement profiles in many different ways. ProVAL is a product developed by The Transtec Group through a contract with the US Federal Highway Administration (FHWA) and the Long Term Pavement Performance Program (LTPP). Using ProVAL 2.72 software, the road profiles were analyzed using the rolling straightedge simulation. Results showed that the approach slabs and the deck were in violation of the 3.2 mm in 3 m (1/8 inch in 10 feet) rolling straightedge requirement outlined in ODOT Specification 451.12 - Surface Smoothness (State of Ohio, Department of Transportation, January 2005). This was consistent with visual observations of the entry approach slab of the right northbound lane where water would pond during and after a rain. Numerous smoothness violations occurred in the left wheel path of both outside lanes. Figure 2 shows the straightedge violations of the left wheel path of the right hand northbound lane on the bridge. Figure 3 shows the straightedge violations of the right wheel path of the same lane on the bridge. Note the large deviation spikes near 32 m, 91 m, 151 m, 210 m, and 268 m (105 ft, 300 ft, 495 ft, 690 ft, and 880 ft) are locations of sliding plate expansion joints. Nearly the entire right wheel path was constructed within smoothness specifications if you exempt the expansion joint locations.

Figure 2. Rolling straightedge analysis, left wheel path of right northbound lane.

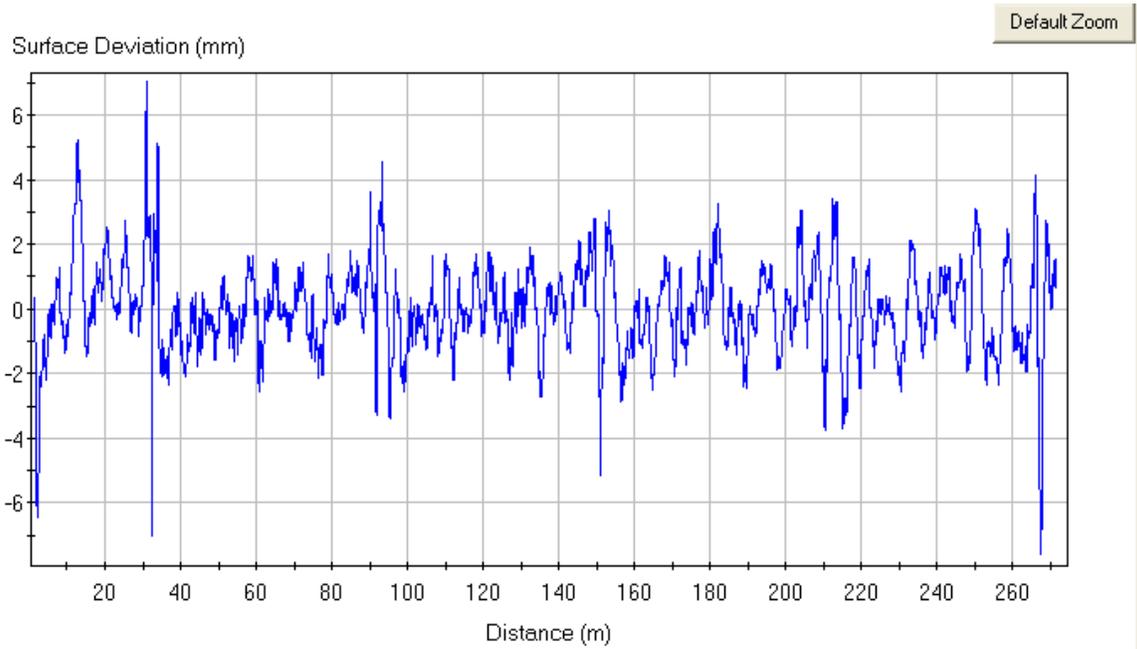
Figure 3. Rolling straightedge analysis, right wheel path of right northbound lane.

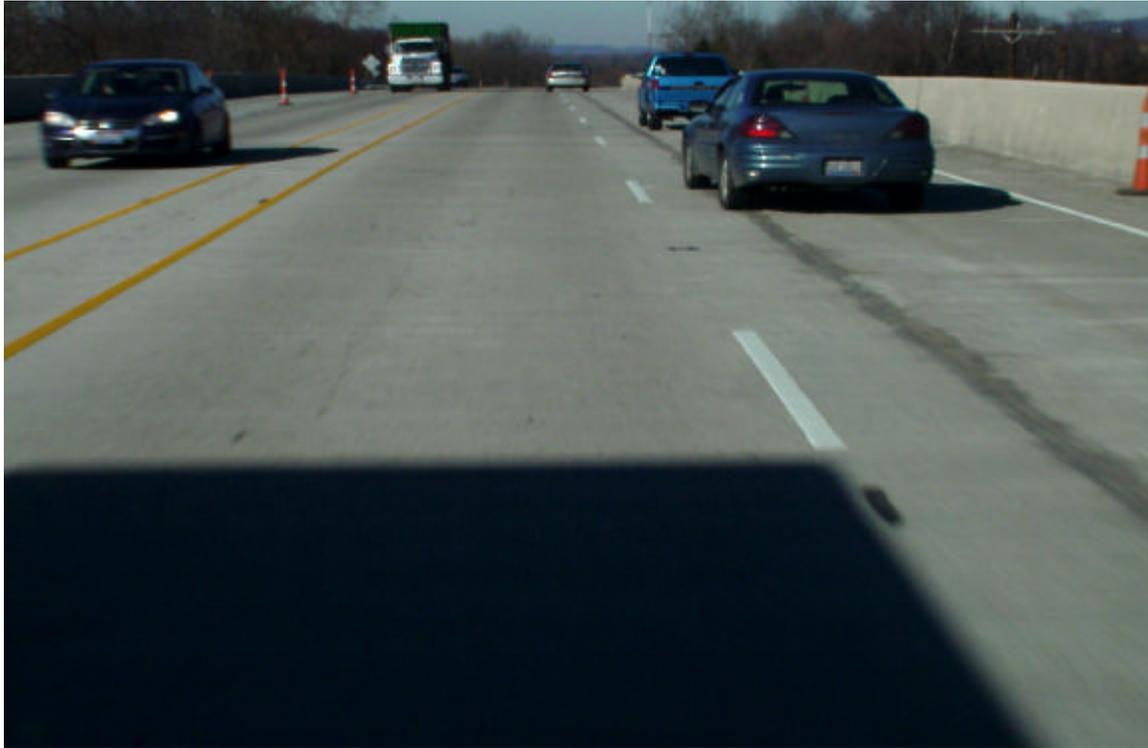
The bridge deck was placed in phases that resulted in construction joints being located in the left wheel path of both outside lanes. This caused the outside lanes to ride rougher than the inside lanes by comparison. Figure 4 shows one of the construction joints on the bridge deck.

Figure 4. Construction joint in left wheel path of right lane.

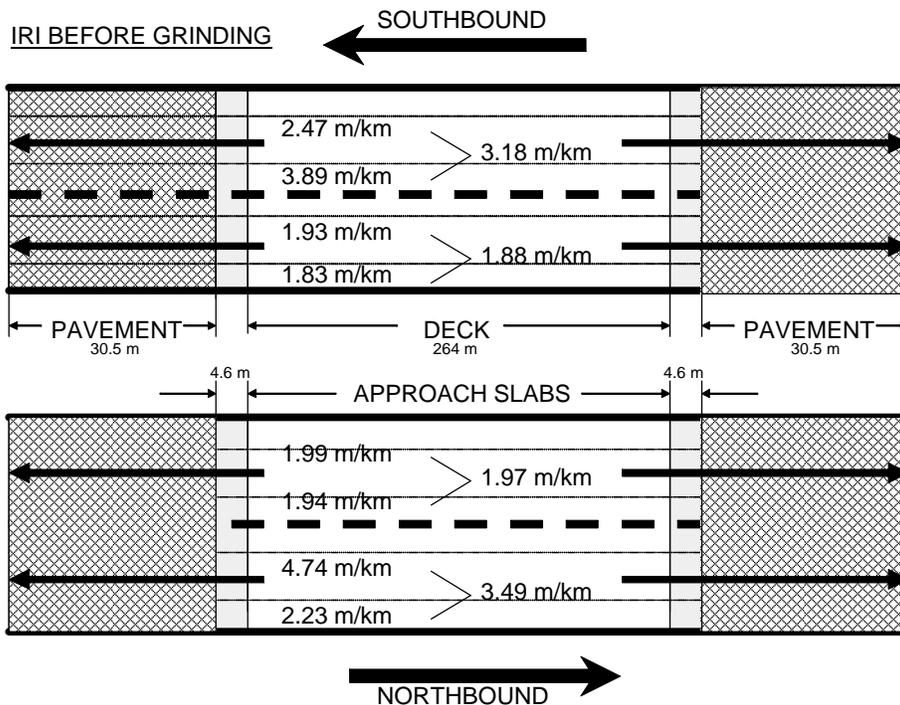
The International Roughness Index (IRI) was the rideability (smoothness/roughness) metric used on this project to objectively evaluate the ride quality at the bridge encounter. IRI is an algorithm based on a generic vehicle suspension system. The IRI simulates suspension movement as the generic suspension model travels over the input road profile(s) at a simulation speed of 80 km per hour (50 miles per hour). The units are vertical accumulated distance of suspension stroke (between the axle and body of the vehicle) per longitudinal distance of travel (Gillespie, 1992). Units are often reported as meters per kilometer (or inches per mile). Thus, lower values of IRI are smoother riding while higher values are rougher riding. The FHWA has determined ranges of IRI that fit particular categories (very good to very poor) of road roughness on our highways. Those ranges are as follows: Very Good - IRI below 0.95 m/km (60 in/mile), Good - IRI up to 1.50 m/km (95 in/mile), Fair - IRI up to 2.68 m/km (170 in/mile), Poor - IRI up to 3.47 m/km (220 in/mile), and Very Poor - IRI exceeding 3.47 m/km (220 in/mile) (FHWA, 2004). The IRI data for each wheel path of the four lanes is shown in Figure 5.

Figure 5. IRI data for each wheel path and lane before grinding.

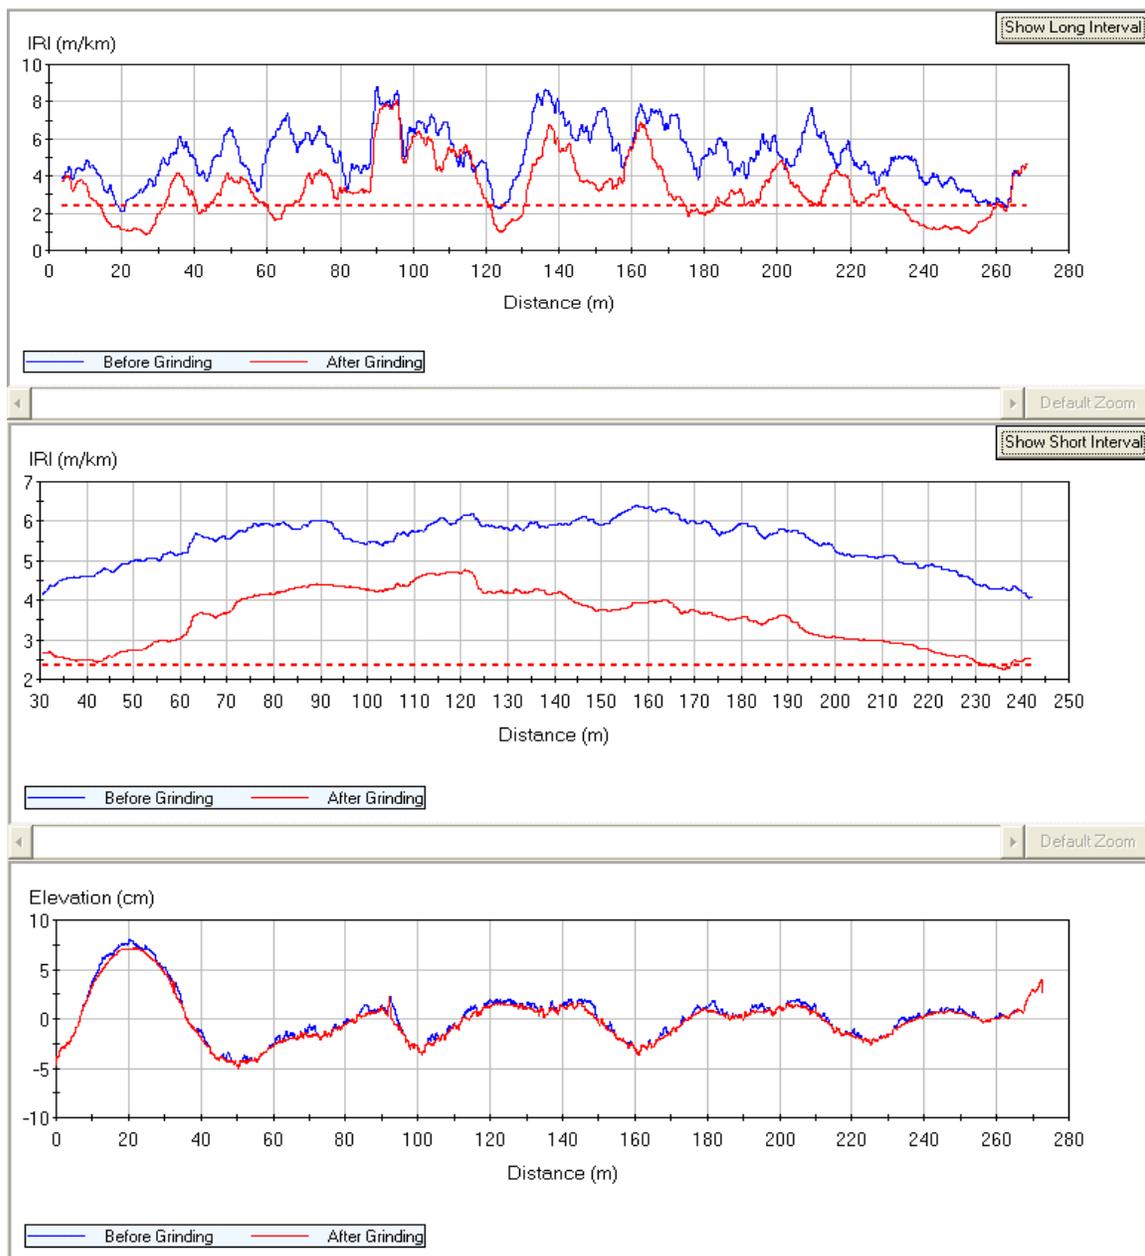
Figure 6. Grinding simulation of left wheel path (deck and approaches only) on northbound right lane, short/ long base length IRI, and road profile.

?? Diamond grinding – This was the solution of choice for several reasons. It was the only systematic solution that addressed smoothness holistically for the pavement, approach slabs and deck. Grinding could occur anywhere on the surface with exception to steel sliding plate expansion joints. This solution had a predictable outcome verified by the FHWA ProVAL software utilizing the built in diamond grinding simulator (Swan & Karahimas, 2003). Grinding simulations were run on the collected profiles to demonstrate how much benefit (in terms of IRI improvement) could be expected by grinding a particular area utilizing one or two passes of the diamond grinder. Figure 6 shows the before and after continuous (Sayers, 1990) short, 7.6 m (25 ft), and long, 61 m (200 ft), base length calculation of IRI as well as the profile of the left wheel path north bound right lane of the deck and approach slabs as determined by ProVAL using the diamond grinding simulation with one pass of a grinding machine.

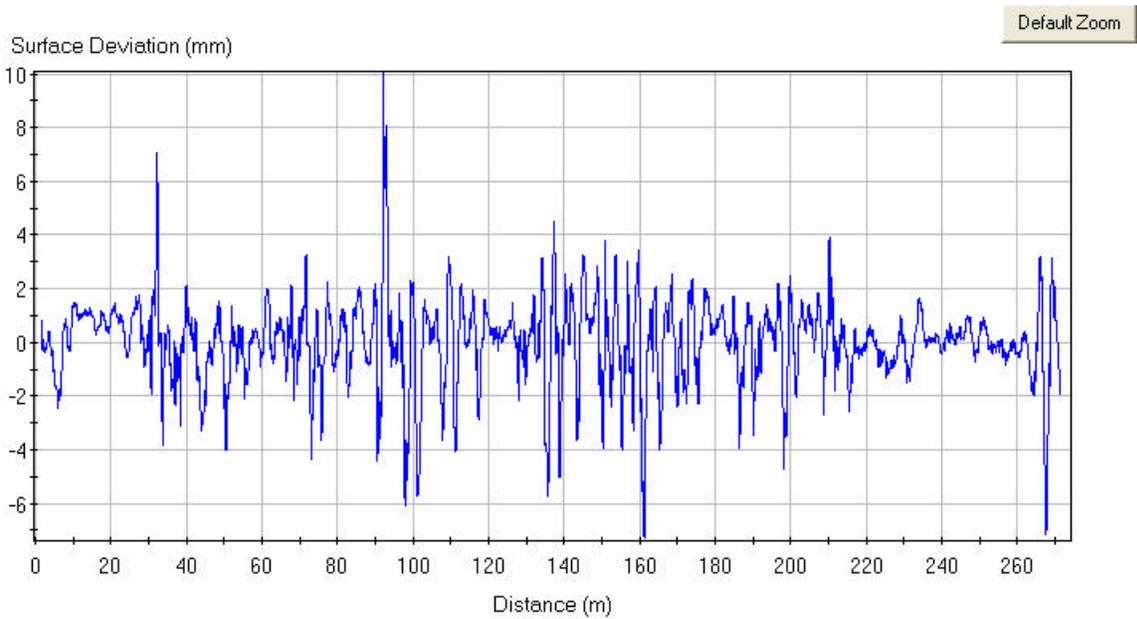
In all three of the targeted areas, the predicted improvement was exceeded. There are two possible reasons for this. The first is that ProVAL’s default value for grinding head depth is zero. This means that the bottom of the head is in line with the bottom of the wheels of the machine, as if all were resting on the same plane. The default value for head height was used in all simulations. There was no way to validate the head depth of the grinder when it was used as there is no gauge and no easy way to reference the head height. It is likely that the grinding head was actually operated at a height deeper than the default value of zero. Further research would be required to validate this hypothesis. Another possible reason is that the simulation only used one pass in the left wheel paths of the two outside lanes over the longitudinal construction joint in the bridge deck. The grinder did not make one pass 1 m (3 feet) wide (width of the grinding head) in the center of the wheel path. Instead, the grinder made two passes, one tapering in laterally from the center lane line and another overlapping somewhat and tapering out laterally to the center of the lane. This in effect was more like a double forward grind than a single forward grind over the left wheel paths. It is worth noting that grinding the left wheel path did not correct all rolling straight-edge violations. See Figure 7 for such analysis after grinding.

Figure 7. Rolling straightedge results after grinding left wheel path of the northbound right lane.

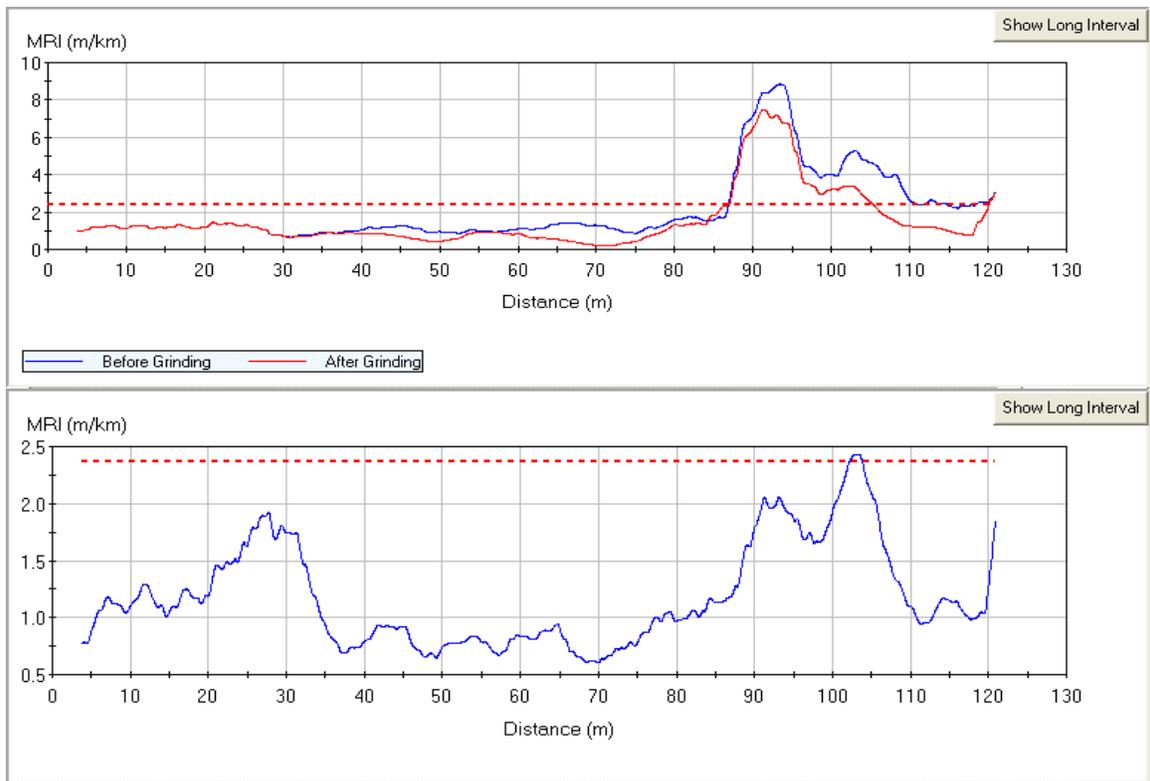
Grinding did cause an increase in roughness in one localized area. This increase in roughness was not predicted in the simulation. The continuous short base length IRI analysis reveals this moderate increase at the beginning of the pavement section which was ground leading into the bridge at the northbound right lane. It is suspected that this increase in localized roughness was due to the simulation's inability to taper in and out at grinding section termini points. Figure 8 illustrates this non-predicted increase in roughness.

Figure 8. Before / Predicted IRI of grinding and actual IRI after grinding with grinder induced roughness.

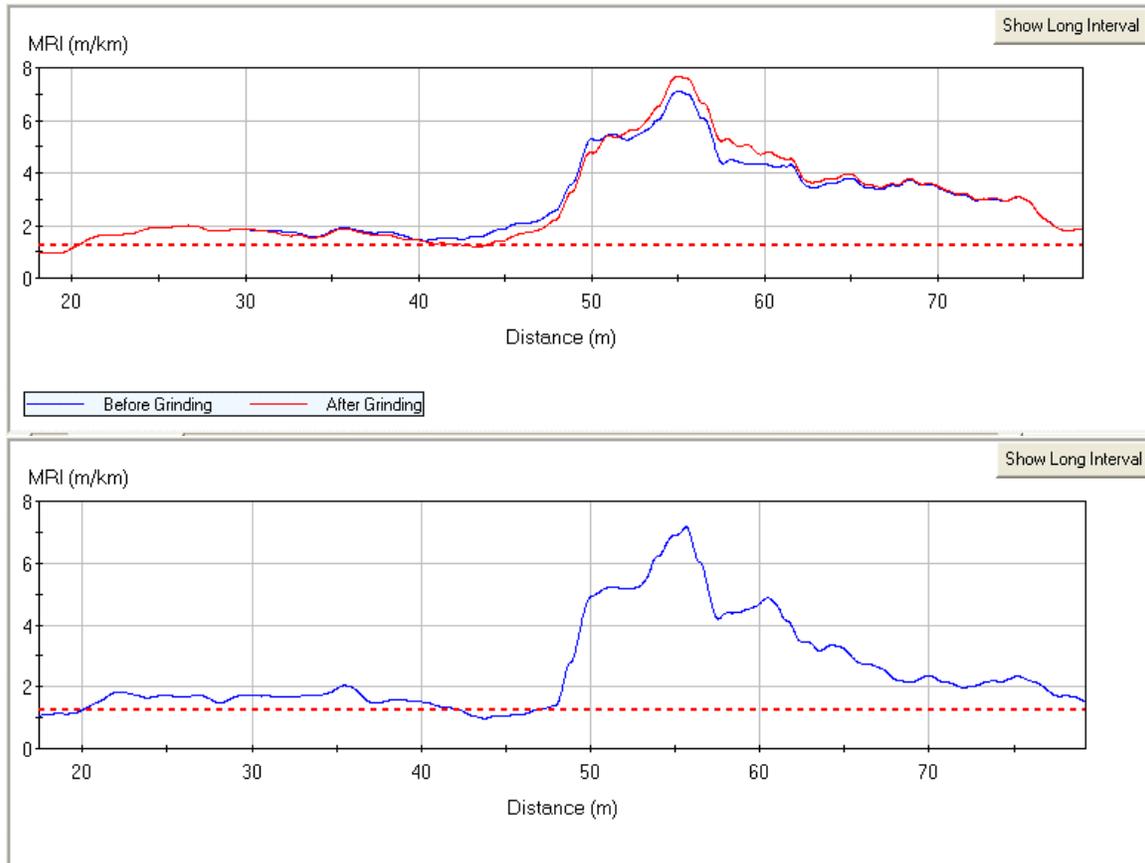
The pavement leading up to the bridge in the right lane southbound direction was ground with one forward pass full width of the lane. Although the ProVAL grinding simulation predicted only minor improvement, it was decided to grind this section as the grinder was already going to be in the vicinity to grind the left wheel path. The grinding foreman had also stated that he could make significant improvement by doing so. Figure 9 graphically shows the predicted and actual improvement.

Figure 9. Before / predicted and actual IRI of southbound right lane entry to bridge.

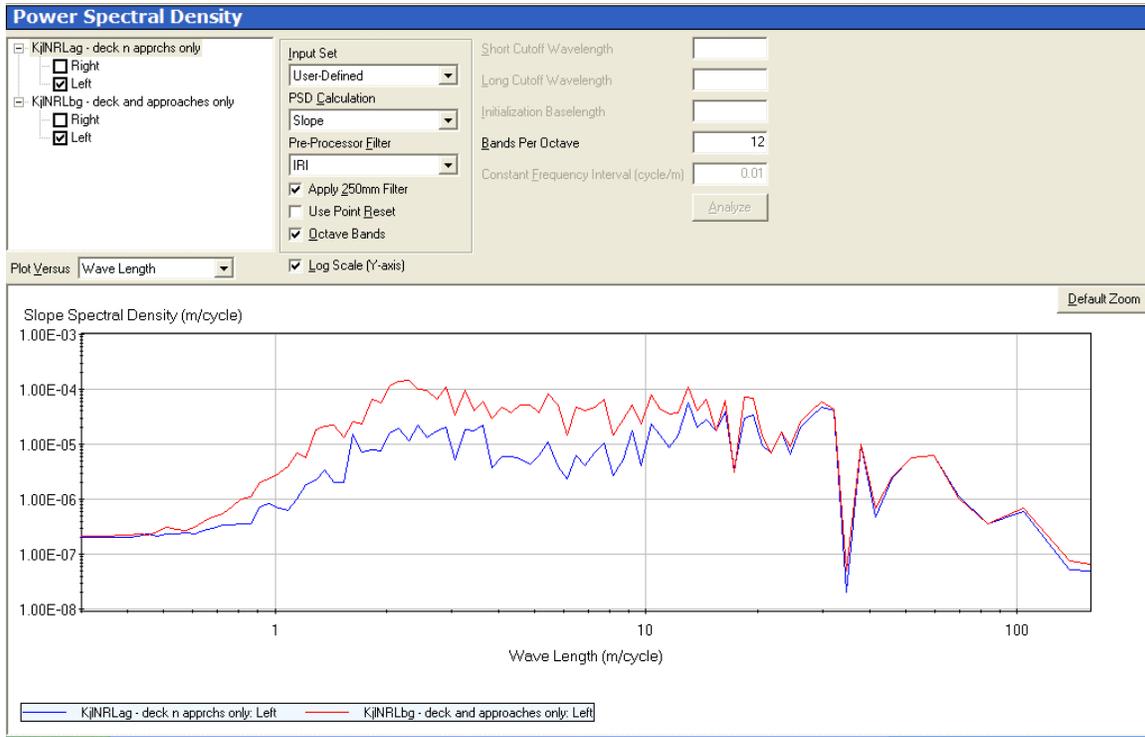
A diamond grinder is limited by its geometry in what roughness content it can improve. Bumps in the profile are more likely to be ground down while dips may not be improved and possibly only lengthened. The grinder used on this project had a wheel base of 5.5 m (18 feet) between the pivot points of the front axle and rear tandem axles. Roughness events less than the wheel base are more likely to be improved by grinding. As roughness events exceed the wheel base of the machine, the benefit of grinding attenuates until the grinder just follows the existing road profile. This can be evidenced by Power Spectral Density (PSD) analysis (Sayers & Karamihas, 1996). The PSD analysis was used to plot the roughness energy of the profile by wavelength. Figure 10 shows such analysis before and after profiles of the left wheel path northbound right lane. It has been pre-filtered for wavelengths of roughness that affect the IRI statistic.

Figure 10. PSD analysis of profiles before and after grinding.
